Shock machine for the mechanical behaviour of hip prostheses: a description of performance capabilities

Juliana Uribe, Jean G  ringer, Bernard Forest

Juliana Uribe, Jean G  ringer, Bernard Forest. Shock machine for the mechanical behaviour of hip prostheses: a description of performance capabilities. *Lubrication Science*, 2012, 24 (2), pp.45-60. 10.1002/lis.167 . hal-00682226

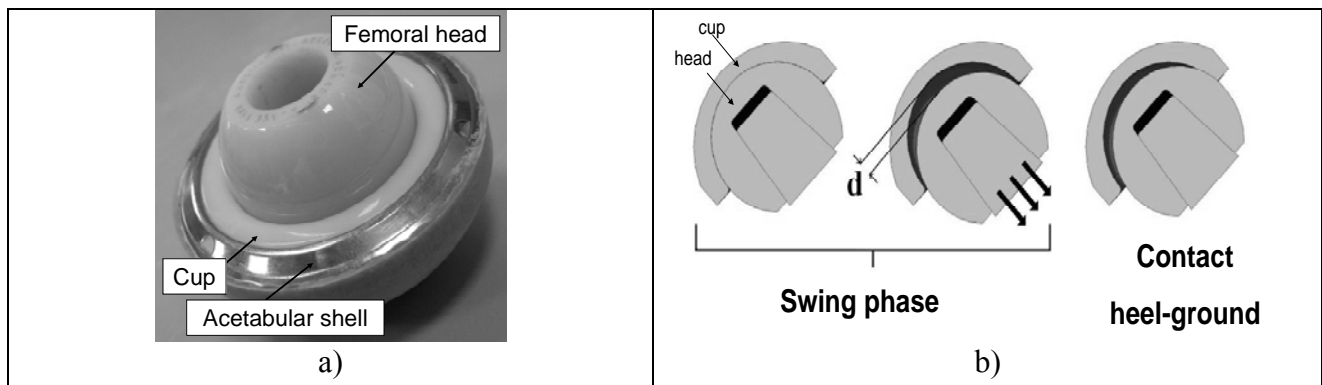
Figure 1. a) Hip prosthesis and b) Microseparation phenomena, d represents the distance of microseparation^{3,4}.

Total hip arthroplasty consists of replacing hip joint with an artificial femoral head, cup and acetabular shell, Figure 1a. Because of the increasing life expectancy, there is a need of prostheses with a longer lifetime. Ceramics are submitted to lower friction and more reduced wear than the ones of metal or polymer (Ultra High Molecular Weight PolyEthylene) bearing surfaces.^{1,2} Aseptic loosening with accompanying osteolysis is less frequent for ceramics cups compared to polymer ones, therefore better long term results are obtained. However, ceramics could be worn and, in some cases fractured, when subjected to shocks.

To reproduce *in vitro* the *in vivo* wear, a description of the hip joint biomechanics is needed. Normal gait cycle has two force peaks. After hip replacement, a microseparation between cup and head could occur. Thus, when heel hits ground, a shock is produced with a vertical force^{3,4}, Figures 1b and 2, up to 600% body weight⁵, which means approximately a force of 9 kN for a patient who weights 150 kg.

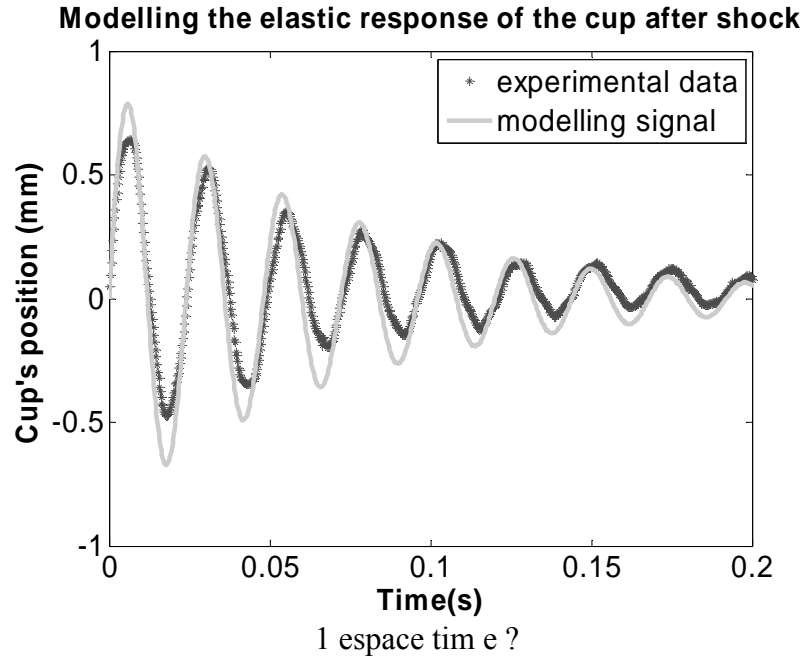
Figure 6. Results for a square signal, with a microseparation of 1.3mm and a force of 9kN, black dotted line: the elastic response of the cup after the shock, gray continued line: the modelling signal.

Since the response of the cup was similar regardless the signal studied, we decided calculating the parameters k and c using only one type of signal. As an example, the parameters were calculated using Matlab[®] for a square signal, with a load of 9kN and a microseparation of 1.3mm.

As can be seen in Figure 6, the underdamped oscillator model fits experimental data well. The k and c values will be adopted in a finite element modelling, further investigations not mentioned in this work, for reproducing the movement of the cup after a shock and studying stresses distribution on the assembly cup-head.

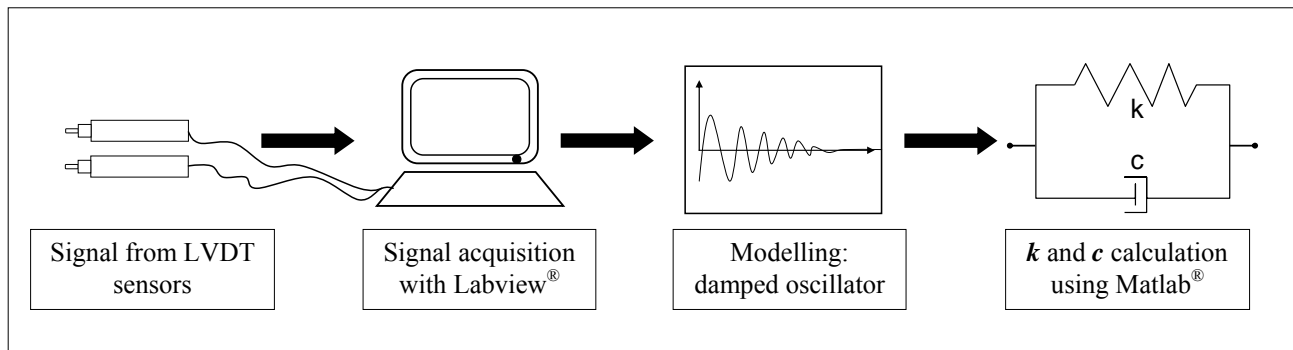
Figure 7. Diagram of data acquisition and postprocessing

The process of data acquisition, processing and modelling is summarized in Figure 7. Spring constant, k , and damping coefficient, c , were determined by fitting using Matlab[®].

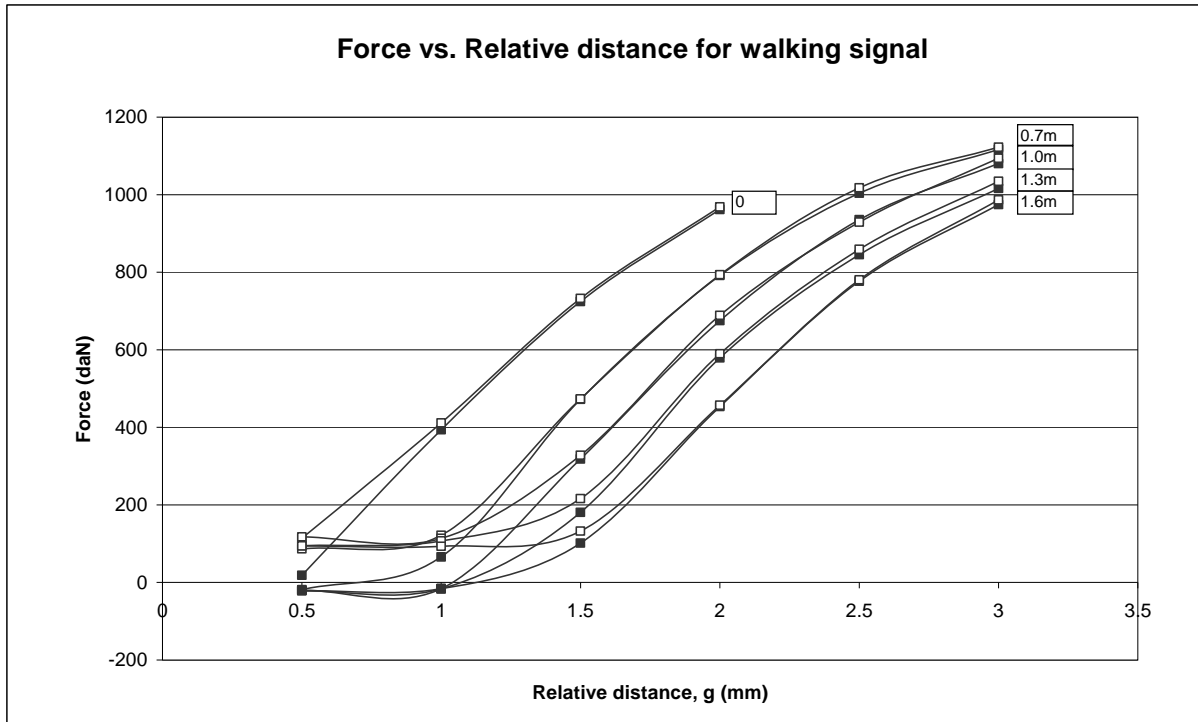
Figure 9. Force on the assembly cup-head as a function of relative distance of the head, for different values of microseparation; □: Ni-DAQ, ■: machine software

The validation tests were made to determine the range of operating conditions to reach a force of 9kN, and 3 signals were studied: sinus, triangle and walking. The signals from Ni-DAQTM and machine software, QuiriTM did not show significant difference for sinus and triangle. On the other hand, for walking signal, recorded signals were considerably different for forces under 2kN. Above 2kN, signals are similar and may be modelled by a linear curve which slope is calculated for each microseparation value (Figure 9 and Table III).

Tests had duration of 20s and were stopped when force was greater than 11kN to avoid fracture of ceramic components and to be consistent with device capabilities. The results in Figure 9 show that a relative distance of 1.8mm has to be imposed to the head for reaching 9kN, without

microseparation. Hence, from Figure 9, an equation was established for microseparation of 1.3mm, the typical microseparation for *in vivo* tests:

$$F = (549.6 \pm 6.8) * g - (571.3 \pm 29.0) \quad (10)$$

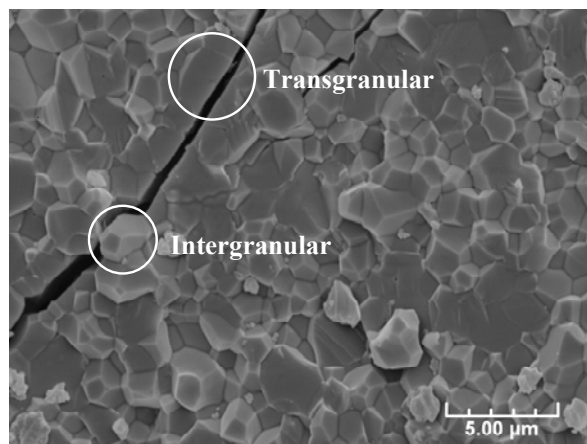
Figure 11. SEM image from alumina debris. Intergranular and transgranular fracture.

Figure 11 shows that debris could be mostly about 1µm of diameter. Shocks induce these typical debris. This experimental result involves some expectations about the reactions of cells. Studies on the biological tolerance of alumina and zirconia nanosized powder on rats suggested that the inflammatory response is similar to those reported for polyethylene or metal particles²³. Nevertheless, testing composites under shocks could lead to intergranular and transgranular fracture and smaller nanometric debris could be found, which might induce an inflammatory response.

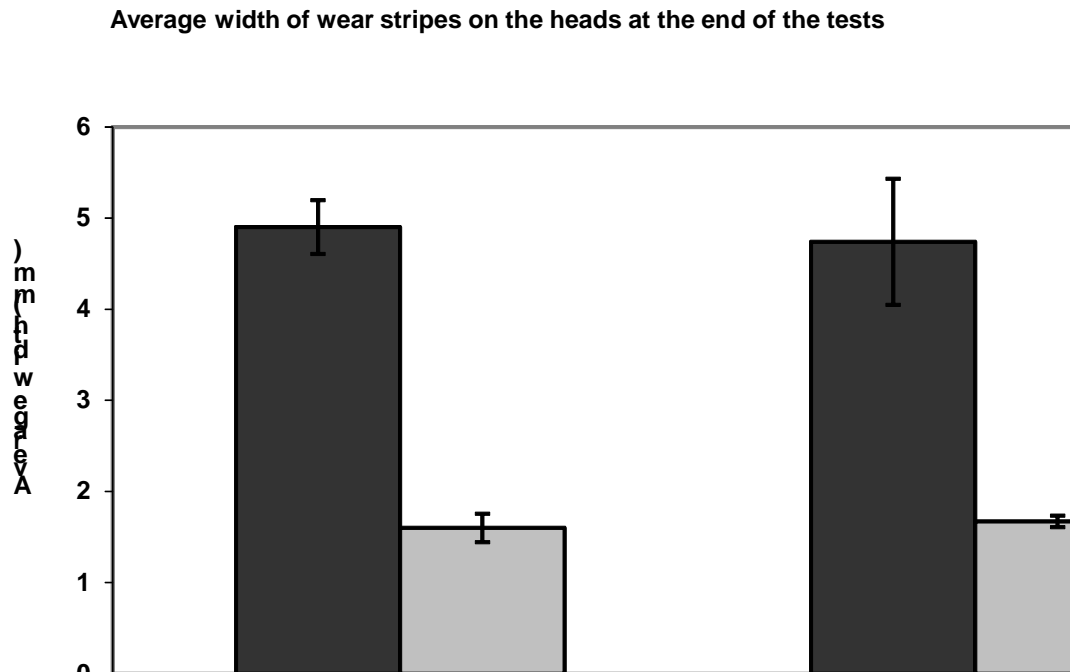
Figure 14. Width of wear stripes for heads in dry and wet conditions.

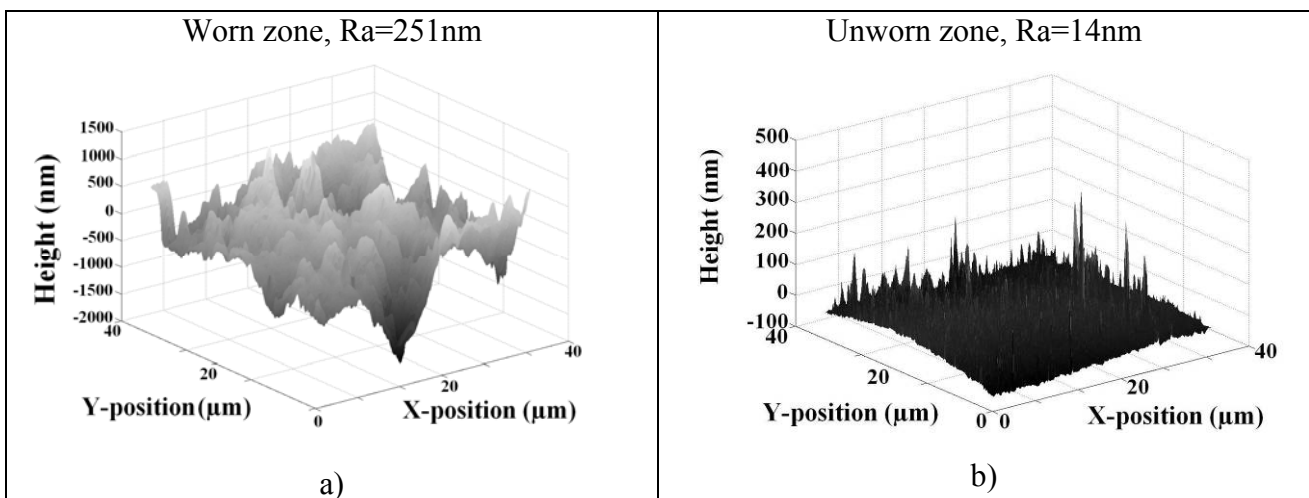
Figure 15. Three- dimensional reconstruction of a roughness profile for both a) worn and b) unworn zones studied by AFM.

After the shock tests, heads were cut carefully and analysed by Atomic Force Microscopy (AFM, Software 6.13) to determine surface roughness evolution. A first order flatten filter was applied to suppress the effect of the spherical shape. 3D-roughness was of 9.1 ± 5.1 nm in unworn zones whereas it was measured to be 277.9 ± 29.4 nm in worn zones. Roughness in worn zones is 20 to 30-fold higher than in unworn zones. These values are comparable with retrieved heads¹². A three dimensional reconstruction of the surface was made using Matlab[®]. Figure 15 shows surface for a worn and unworn zone from the same head.

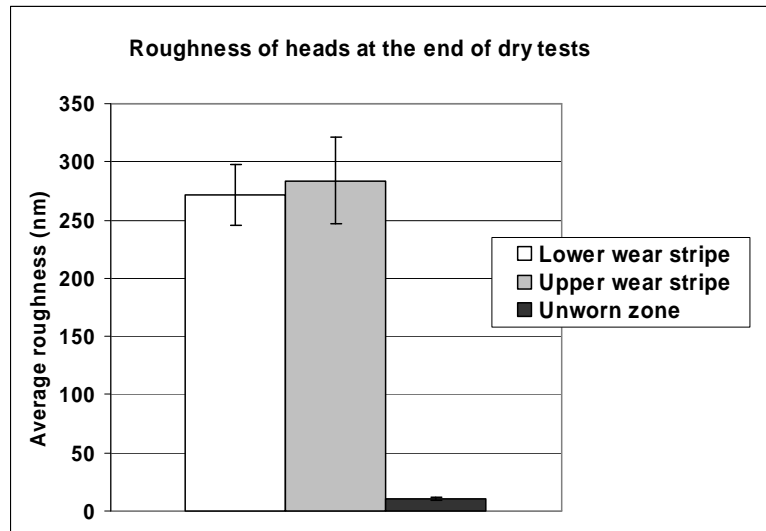
Figure 16. Wear stripe roughness from heads tested in dry conditions.

Analyses by AFM showed a similar roughness for the upper and lower wear stripe, showed in Figure 16.
